# **APS**

# **Troubleshooting Guide**

**SOP-ED-09 A/0**

ALTENERGY POWER SYSTEM INC.

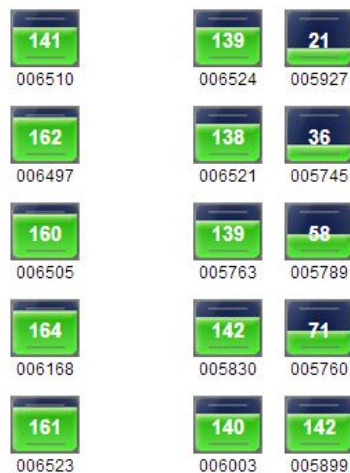
- ✓ Please check 7-day system performance. If the periods of low production are fairly consistent and happen at the same time of day, shading is likely the cause. The following EMA screenshot shows an example of a system with shading impacts.

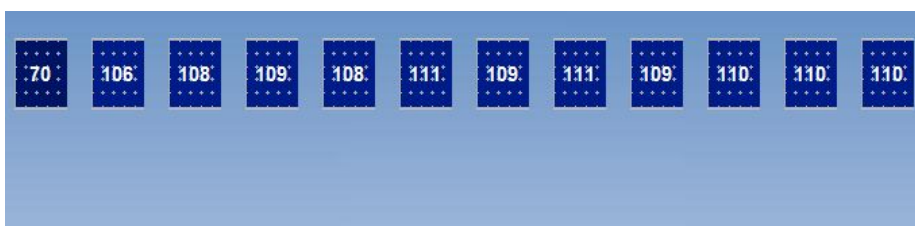
If the DC voltage is always lower than 30V, the module might be failed. Please let an electrician measure the VOC of the module to identify if module is faulty. The following EMA screenshot shows an example with a faulty module.

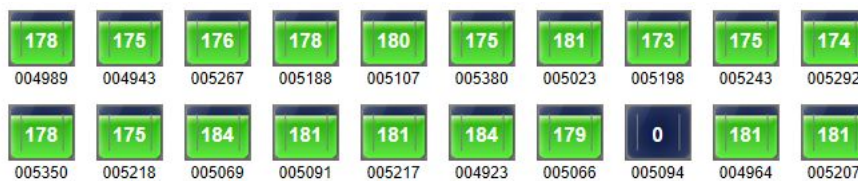
**2. Why is one unit showing 0W production when adjacent units are productive?**

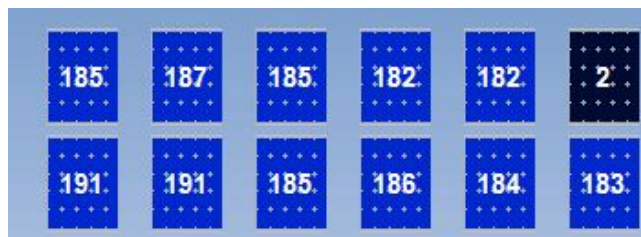
**3. Why is one YC250 unit or one input of YC500 showing 2W, 3W or 4W production when adjacent units are productive?**

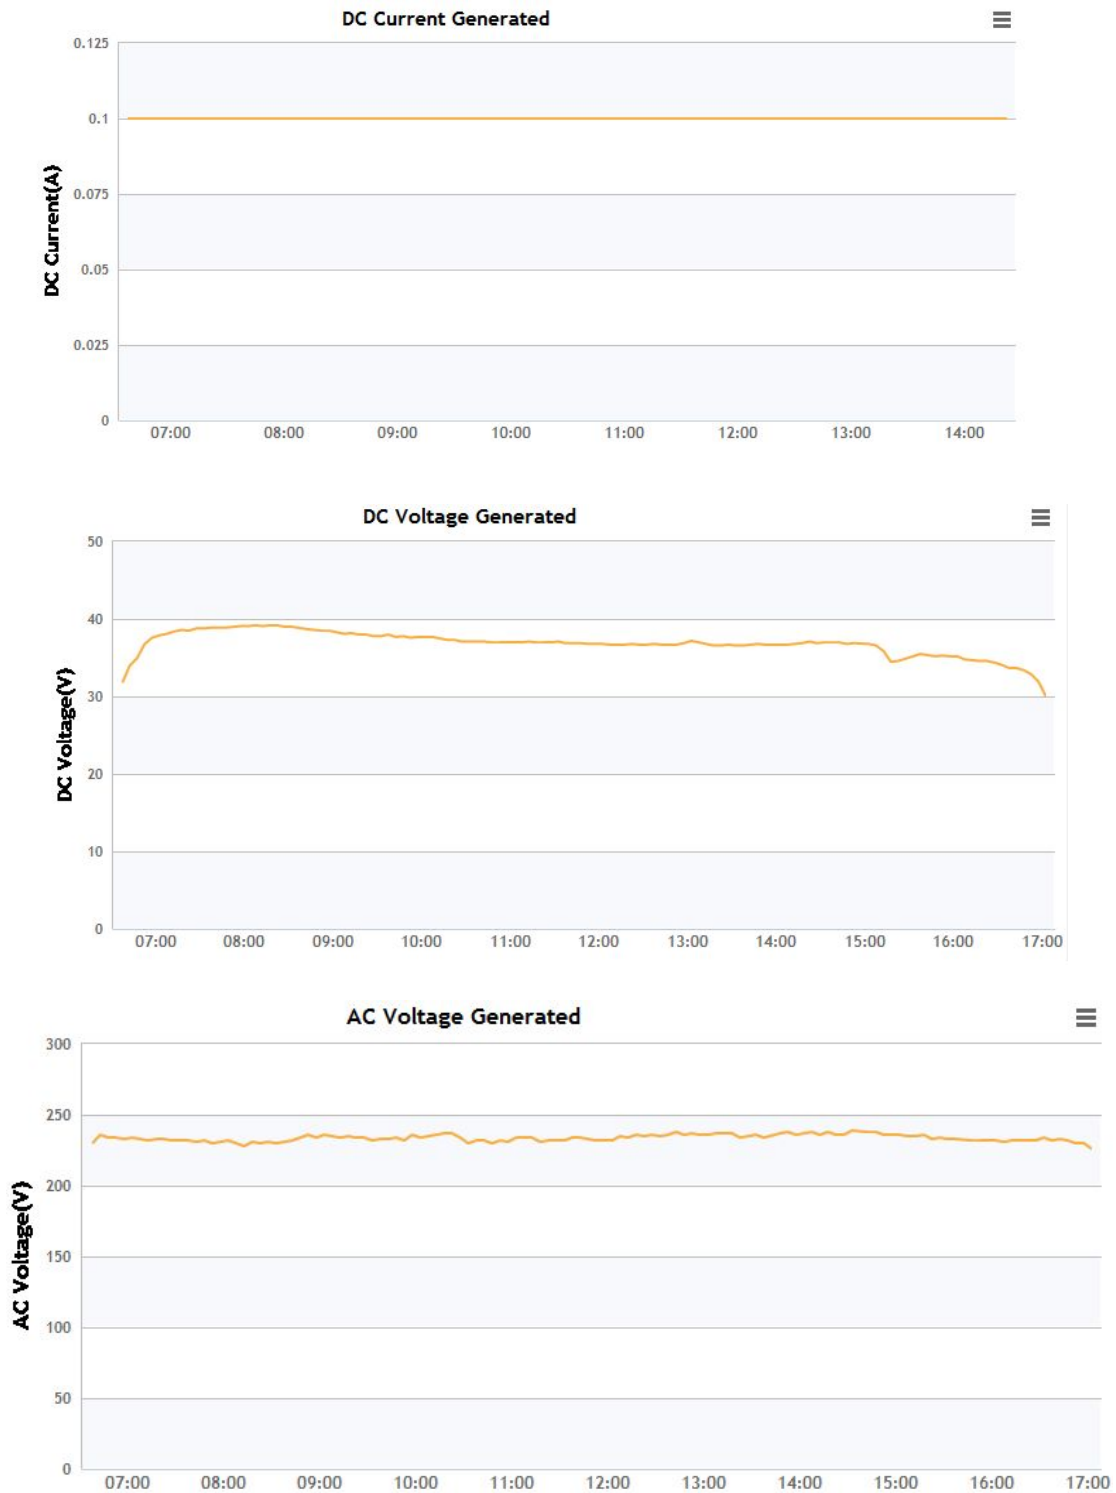
- 1) If  $V_{dc}$  is around 30V and  $V_{ac}$  and frequency is normal while  $I_{dc}$  is almost 0A, inverter might be failed. The following EMA screenshot shows an example of a faulty inverter.

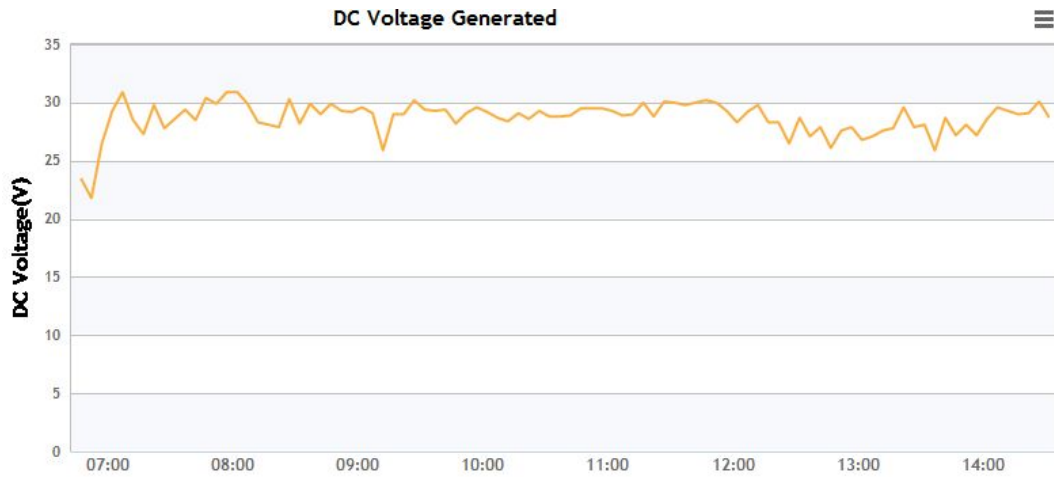
- 2) If  $V_{dc}$  of the YC250 unit is around 30V while  $V_{ac}$  is abnormal. This indicates the inverter is disconnected from the grid and loose AC plug connection or faulty AC connectors might be the cause.

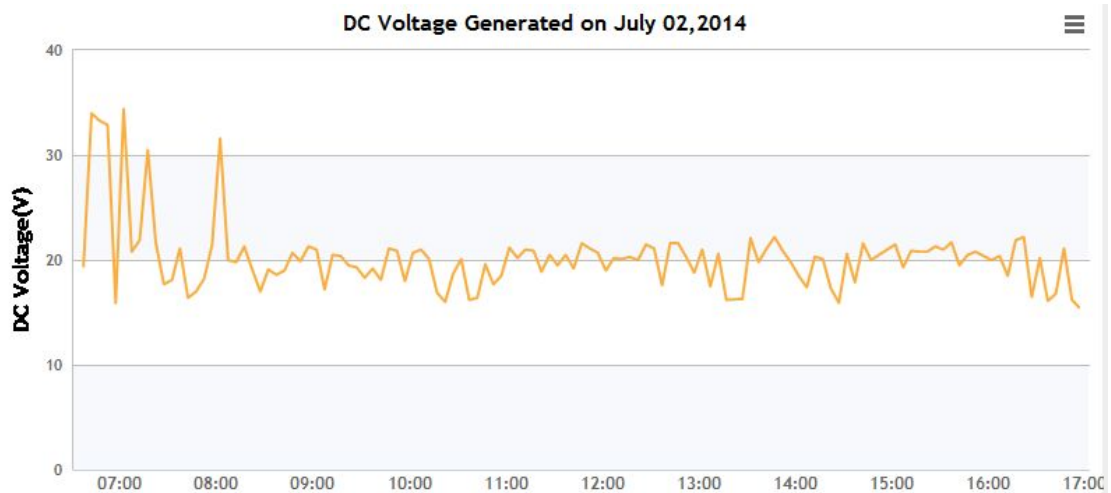
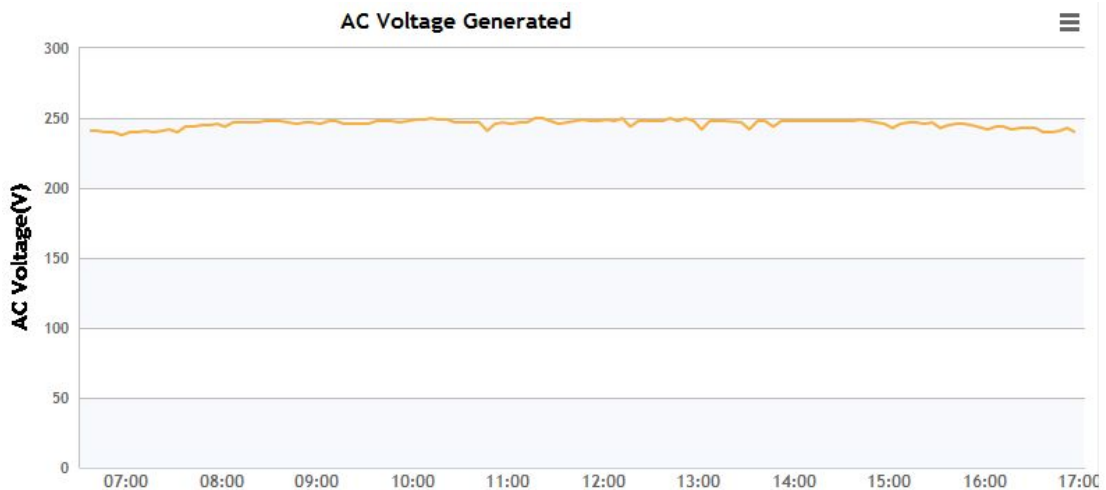
- 3) If  $V_{dc}$  is around 20V or lower than 20V while  $V_{ac}$  is normal, the module might be faulty.

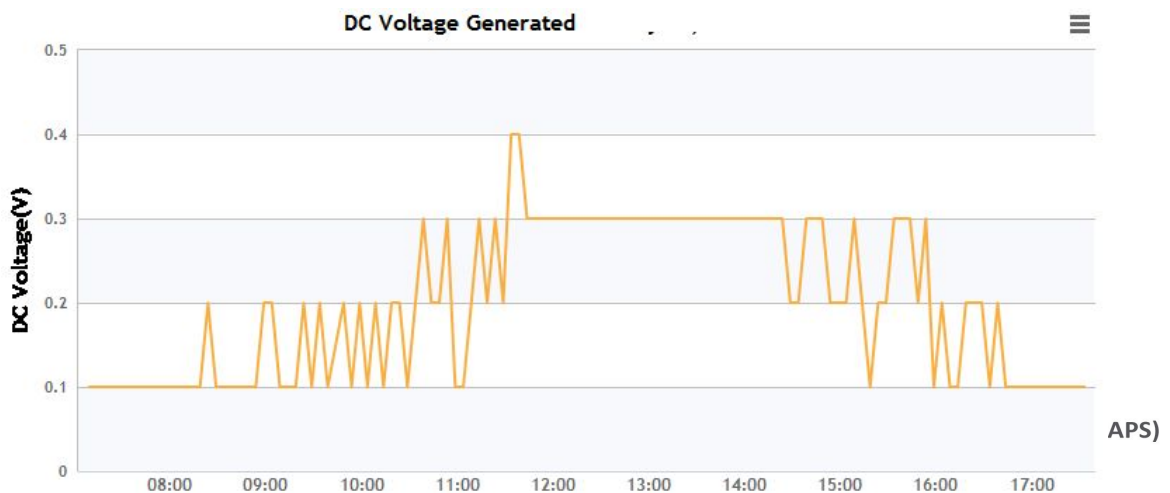
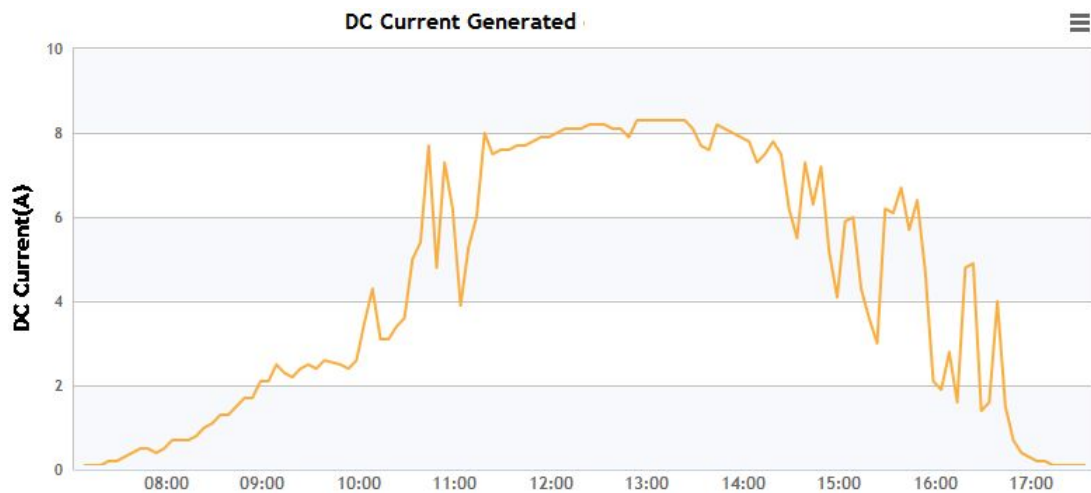
- 4) If  $V_{oc}$  is almost 0 V while there is  $I_{dc}$  reading, the module may be the cause, so please measure the open-circuit voltage (VOC) of the module first. Alternatively, inverter is failed, so please contact APS technical support. See the screenshot below.

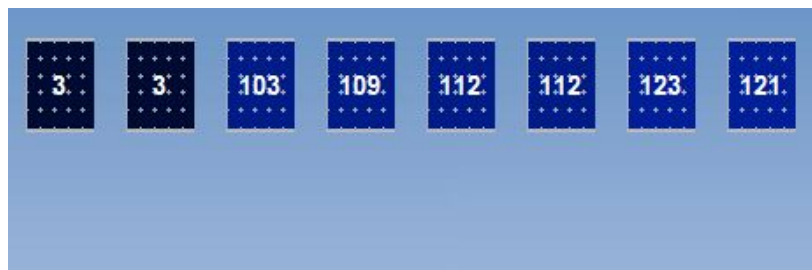
4. Why are A and B inputs of YC500 showing 2W, 3W or 4W production when adjacent units are productive?

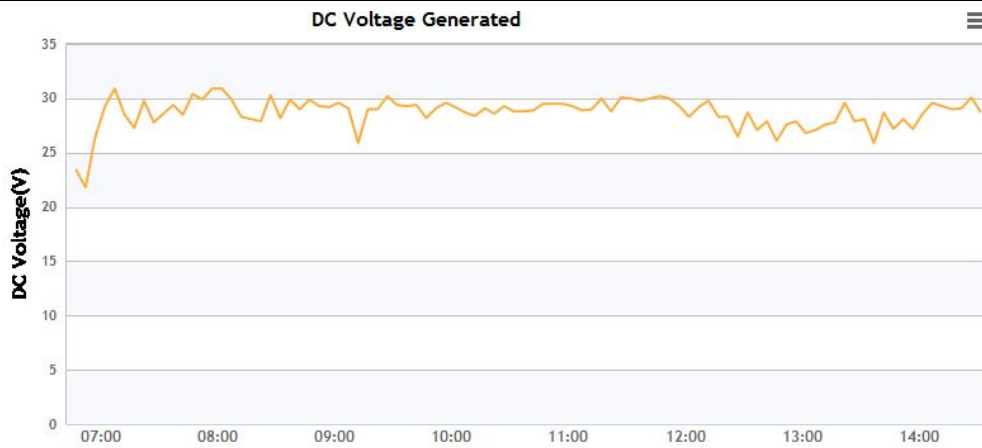
1)  $V_{dc}$  is around 30V while  $V_{ac}$  is abnormal. This indicates the inverter is disconnected from the grid. Alternatively, loose AC plug connection between inverters might be the cause, see the troubleshooting below:

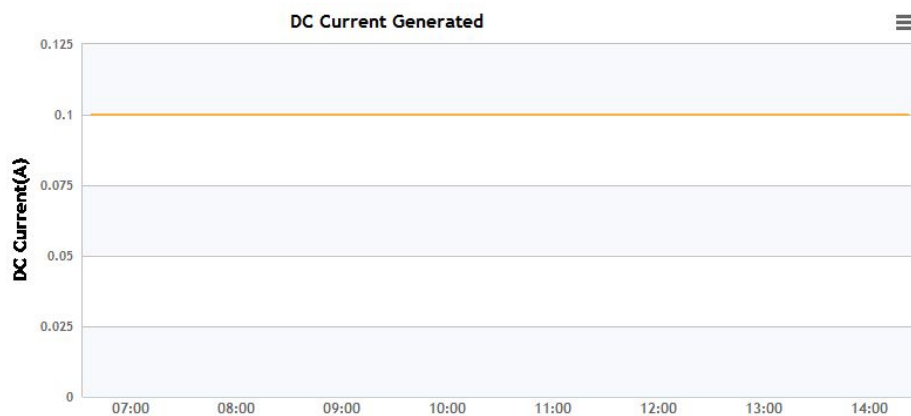
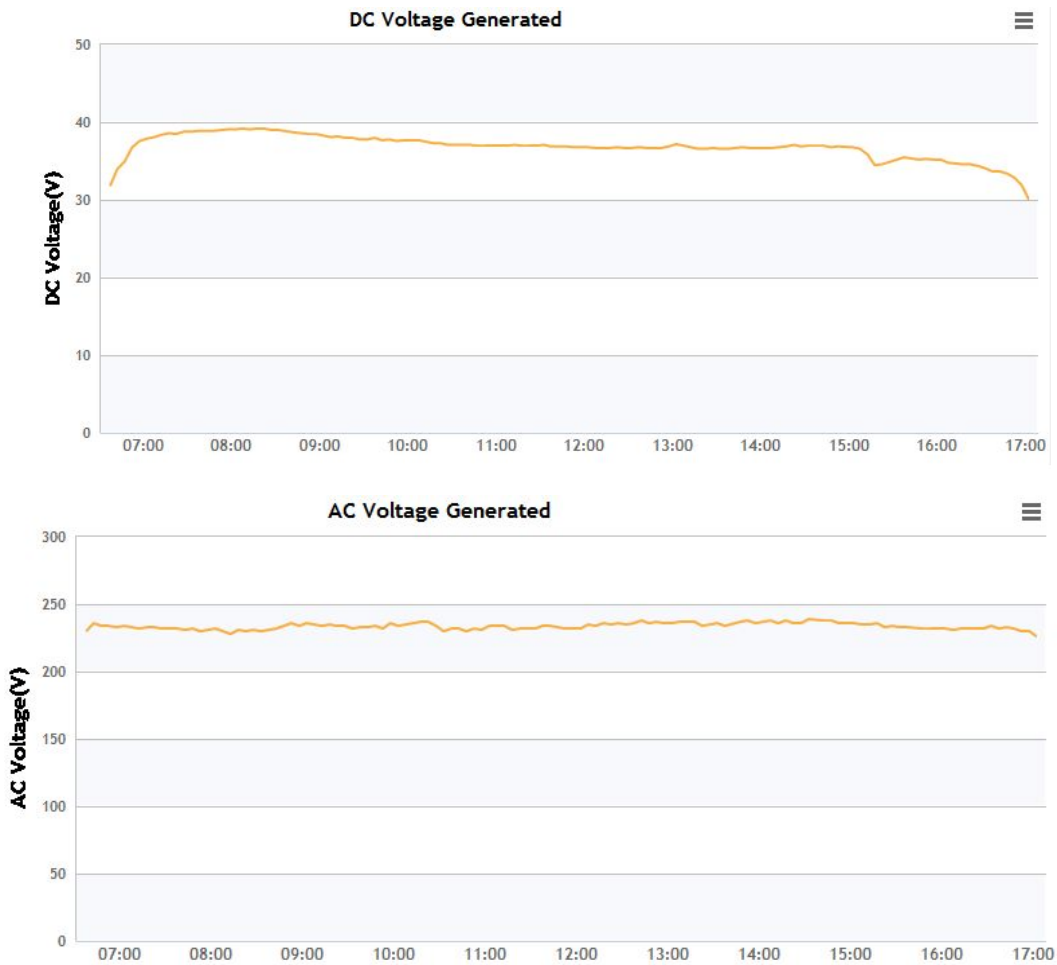
2)  $V_{dc}$  is around 30V and  $V_{ac}$  is normal while  $I_{dc}$  is almost Zero. This indicates the inverter is fault, so please replace it.

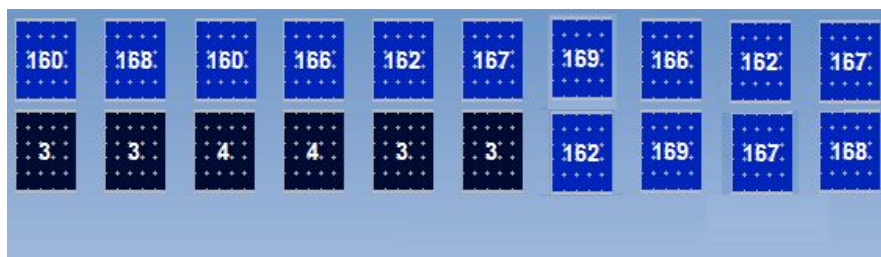
5. Why are couples of microinverters showing 2W, 3W or 4W production when adjacent units are productive?

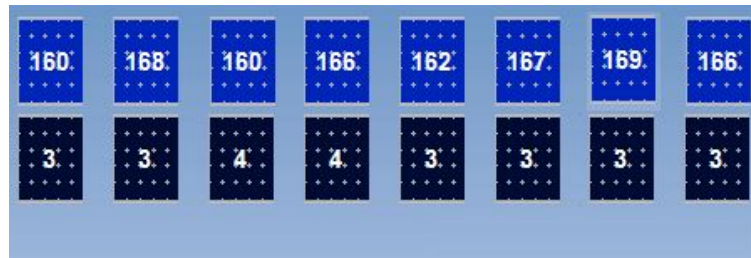
6. Why are all microinverters in one string showing 2W, 3W or 4W production when adjacent units are productive?

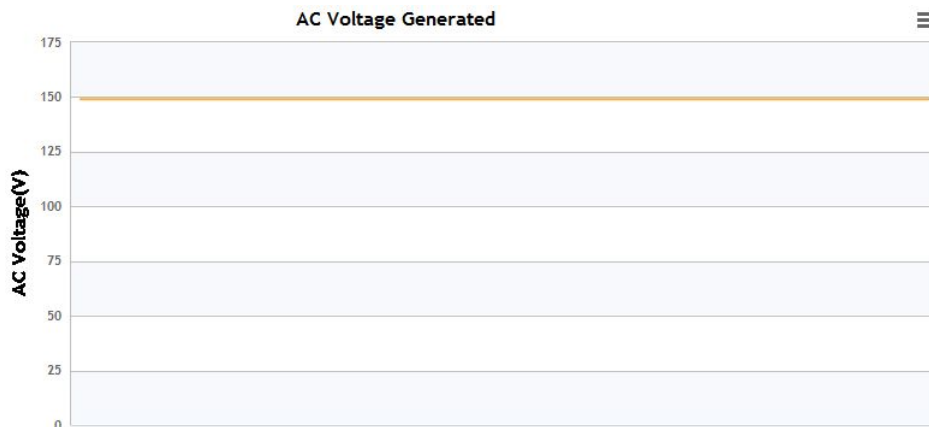
Check AC Measurement in EMA of these units and Vac should be always abnormal like the screenshot below. This indicates that the string is disconnected from the grid. Check that Solar circuit breakers and Isolators in “ON” position.
